# **Premier Inspections**

# January 9th 2021, 12:49 pm

2422 N Park Dr Stillwater OK 74075 Hernandez house 1247

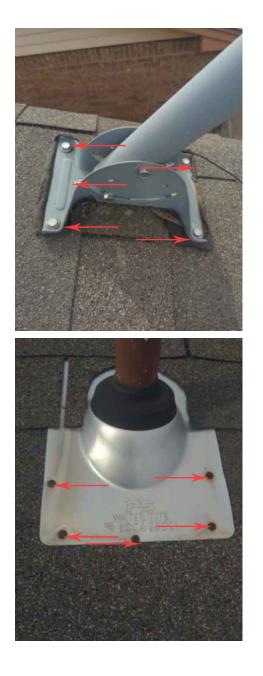
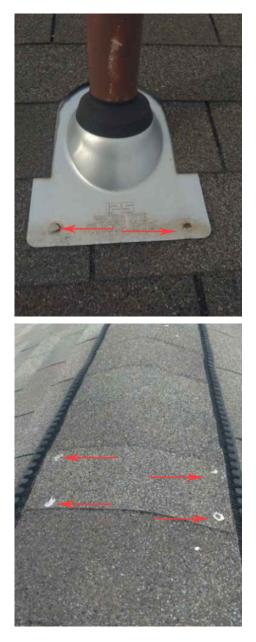
Notes: SHINGLES MISSING / DAMAGED? Satisfactory Notes: ROOF INSTALLATION Fair Notes:

Fair
